SEDIMENTOLOGICAL AND GEOMORPHOLOGICAL EFFECTS OF THE 1997 AND 1998 FLOOD SEQUENCE ON THE LOWER SNOWY RIVER, VICTORIA

WAYNE D. ERSKINE^{1,2}, LISA M. TURNER³ AND TERESA A. ROSE⁴

ABSTRACT: Three floods with flood peak ratios (peak discharge/mean annual flood) ranging between 0.65 and 5.35 occurred on the lower Snowy River in Victoria between June 1997 and August 1998. The June 1998 flood was the largest event downstream of the Rodger River junction where the flood peak ratio was >4 . Pre- and post-flood investigations were carried out at the three Snowy River benchmarking sites in Victoria (McKillops Bridge, Sandy Point and Bete Bolong) to determine the impact of the floods on channel-boundary sediments and morphology. Few significant changes in graphic grain-size statistics for channel-boundary sediments were found at McKillops Bridge and Sandy Point. At Bete Bolong, there were many significant changes in the grain-size statistics of both the bed material and bank sediment. The variance and mean of a number of benchfull and bankfull channel morphologic parameters (width, area, mean depth, maximum depth, width–maximum depth ratio) did not change significantly at McKillops Bridge an

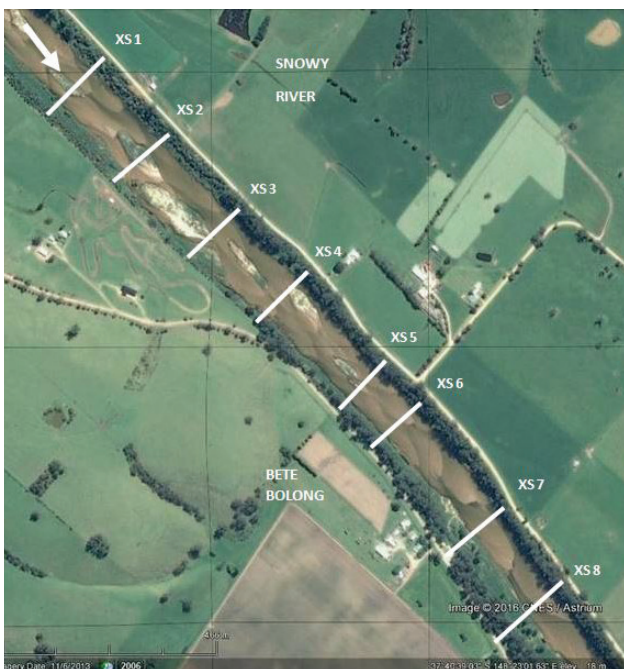
Figure 4: Vertical air photograph of benchmarking site at Bete Bolong in the Orbost Alluvial Reach showing location of cross sections. The Jarrahmond gauge is located about 0.5 km upstream on the left bank.

3. *Bete Bolong* (station No. 222025) is a 1623-m-long section of channel containing eight cross-sections at Bete Bolong, immediately downstream of the Jarrahmond gauging station (gauge No. 222200) (Figure 4). This site exhibits a straight, relatively uniform sand-bed stream with multiple thalwegs, separating longitudinal and/or transverse bars (Erskine et al. 1999a). It is located in the Orbest Alluvial Reach (Erskine et al. 2001). Bed slope is 0.00042 (0.42 m.km⁻¹) and water surface slope is 0.00046 (0.46 m.km⁻¹).

Table 6: Grain size statistics of the bed material collected in 1997 and 1998 at the Bete Bolong benchmarking site. For location of cross sections, see Figure 4.

Table 7: Grain size statistics of the bank sediments collected in 1997 and 1998 at the Bete Bolong benchmarking site. For location of cross sections, see Figure 4.

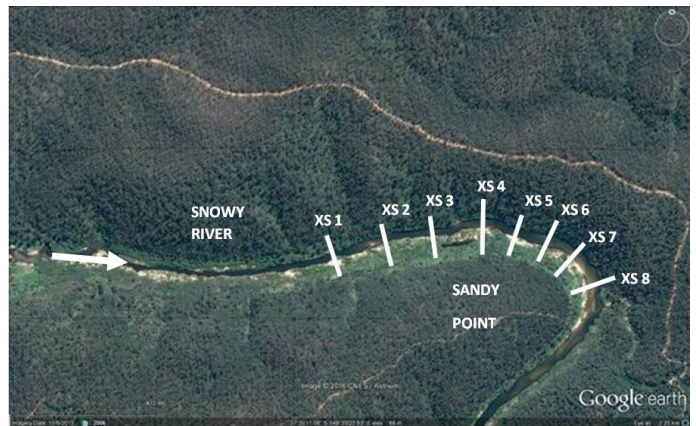
Figure 3: Vertical air photograph of the Sandy Point benchmarking site at the boundary between the Lucas Point and Long Point Reaches showing location of cross sections.

Table 4: Grain size statistics of the bed material in 1997 and 1998 at Sandy Point. For location of cross sections, see Figure 3.

Table 5: Grain size statistics of the bank sediments in 1997 and 1998 at the Sandy Point Benchmarking site. For location of cross sections, see Fig. 3.

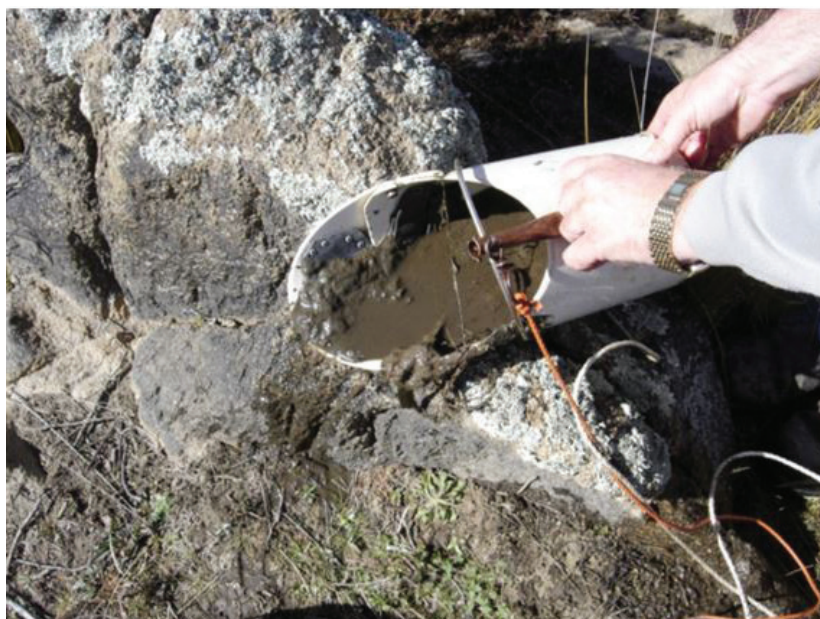
Figure 6: The scoop bed sediment sampler in use at a benchmarking site in the Dalgety Uplands Reach. For location of river reach, see Figure 1.

Bulk samples were collected of soil, sand, fine gravel and mixed sand and fine gravel by spade at multiple sites on the cross-section when the sites were either dry or located in shallow water. At least eight points on the cross-section were combined for a bulk bed sample. A scoop sampler with an inside-mouth diameter of 150 mm (Figure 6) was used out of a boat to obtain bulk samples of bed

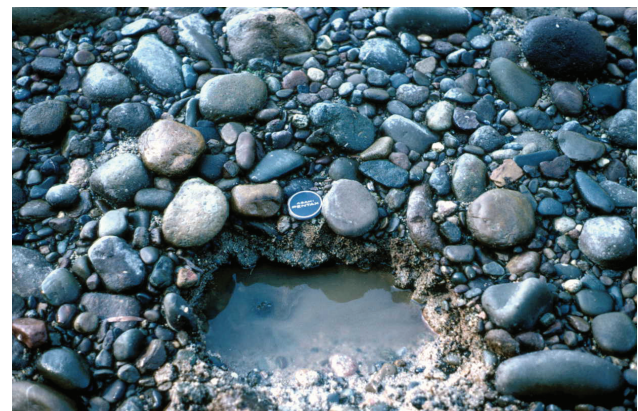
Figure 7: Moderately well sorted, fine skewed, mesokurtic, pebble gravel armour layer overlying low bearing strength very poorly sorted, coarse skewed, very platykurtic, sandy pebble gravel sub-armour sediment on longitudinal bar at cross section 8 at Sandy Point. See Figure 3 for location of cross section.

All sediment sampling was conducted on 2 December 1998 when the mean daily flow was 2174 ML/day at Jarrahmond. A boat was used to access the river bed and the scoop sampler was used to sample at least part of the bed on cross-sections 1, 2, 3, 4, 6 and 7. The original sampling was conducted on 28 April 1997 when the mean daily flow at Jarrahmond was 215 ML/day. The grain-size statistics of each bed-material sample in 1997 and 1998 are outlined in Table 4 and those for each bank sample for each year in Table 5. The armour and subarmour sediments on the longitudinal bar at cross-section 8 are shown in Figure 7.

There were no significant changes in the variance and mean of the grain-size statistics for the bed material before and after the June 1998 flood. While both average median and average graphic mean size increased, as expected (mean d_{50} decreased from -0.79 to -1.53 ϕ or 0.58 to 0.34 mm and mean M_z decreased from -0.96 to -1.31 ϕ or 0.51 to 0.40 mm), the variance of the data was very large and hence the changes were not significant. The lack of change in grain-size statistics before and after the June 1998 flood did not mean that there was no transport of the bed material, only that there were no significant changes in the grain-size distributions. The June 1998 flood was a large event downstream of the Buchan River junction (Table 1) and consequently there were substantial changes in river-bed levels (see next section). Side and longitudinal bars were extensively reworked and armoured by gravels

deposited by receding flood flows on top of low-density, liquified sands (Figure 7). In December 1998, the side and longitudinal bars were still 'soft' with low bearing strength, subarmour sediment (Figure 7).

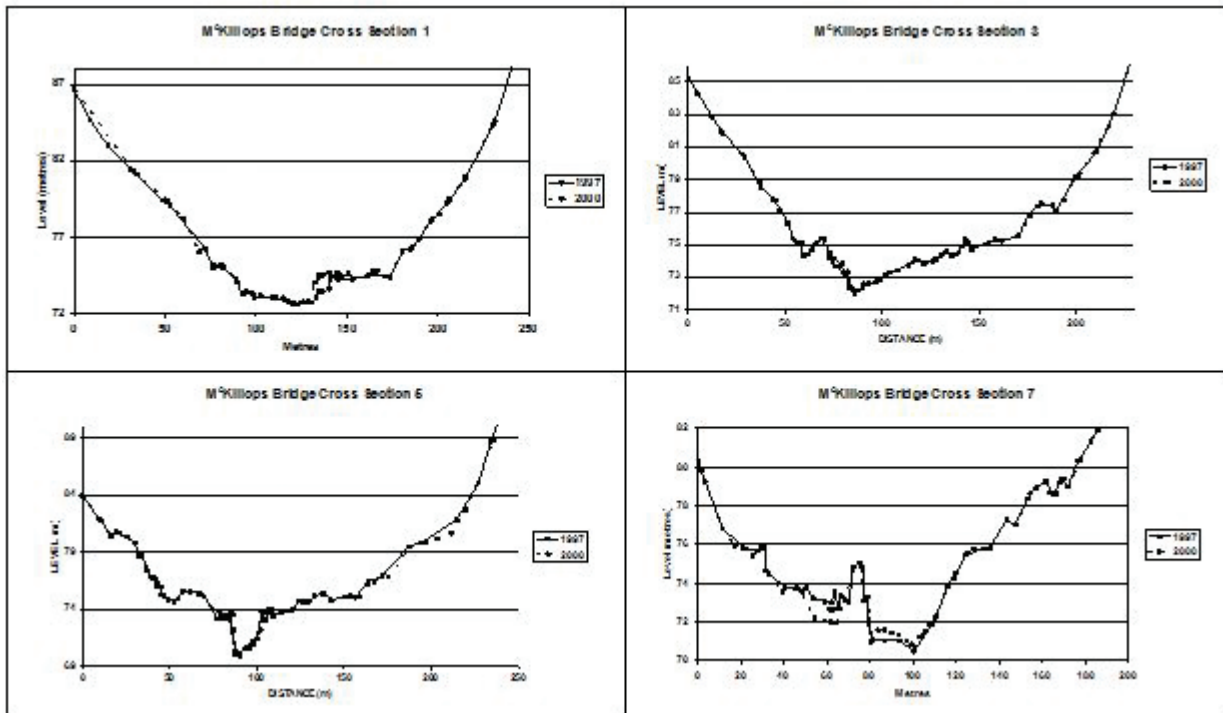
Figure 8: Cross-sections surveyed in 1997 and 2000 at McKillops Bridge. See Figure 1 for location of site and Figure 2 for location of cross-sections.

Benchfull and bankfull channel geometric parameters did not change between 1997 and 2000, except for mean bankfull width–maximum depth ratio which increased by only 2.2% from 20.7 to 21.2 ($p = 0.0069$). This was the largest percentage change in any bankfull-channel geometric parameter although some slightly larger but non-significant changes were recorded in benchfull parameters. Clearly, there were only minor changes in channel geometry as a result of three small floods in 14 months. Many of the channel changes are very minor (see cross-sections 1, 2 and 3), despite the mobilisation of bed material at most cross-sections (Figure 8). Close bedrock confinement limits channel sensitivity to flood-induced change by small events. Many of the benches are founded on a bedrock nucleus and colonised by riparian vegetation, limiting changes in benchfull channel dimensions by such small events.

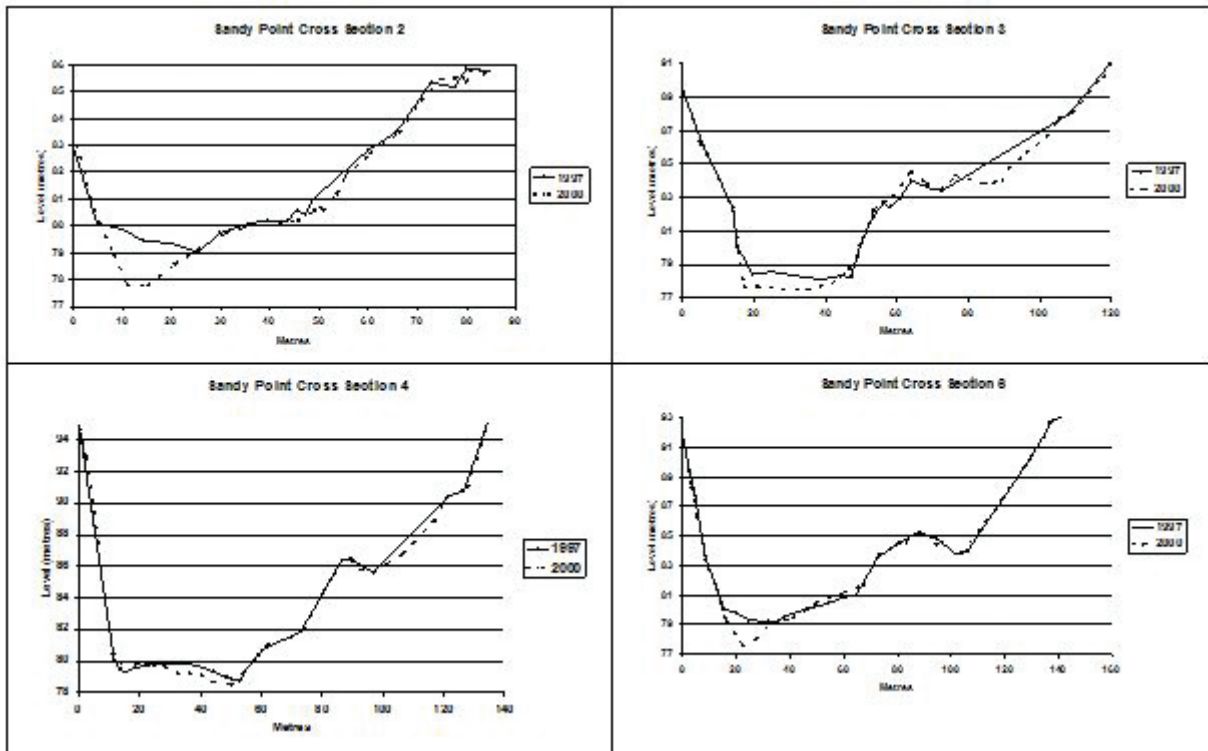
Figure 9: Cross-sections surveyed in 1997 and 2000 at Sandy Point. See Figure 1 for location of site and Figure 4 for location of cross-sections.

There was no significant change in the variance of benchfull and bankfull channel geometric parameters between 1997 and 2000. However, there was a significant increase in bankfull mean depth ($p = 0.024$). Mean bankfull width–maximum depth ratio decreased significantly ($p = 0.031$). While mean maximum depth increased by 8.1%, the change was significant at only $p = 0.068$. However, mean bankfull width decreased by -1.15% and so the resultant change in mean width–maximum depth ratio (-8.5%) was significant. The percentage increases in the mean that were significant ranged between only 2.7% and 7.1%.

The bed was scoured during the June 1998 flood and fill did not always match scour, as predicted by Erskine et al. (1999a, 1999b). As a result, cross-sections 2, 3, 4 and 6 experienced localised scour that persisted after the flood (Figure 9). As the frequency of net scouring floods has been reduced by flow regulation, the resultant pools often do not persist until the next such event (Erskine et al. 1999a). The sand entrained from the bed was often deposited as bars and laterally redistributed onto benches (cross-sections 1, 3 and 5). However, some bench erosion also occurred (cross-

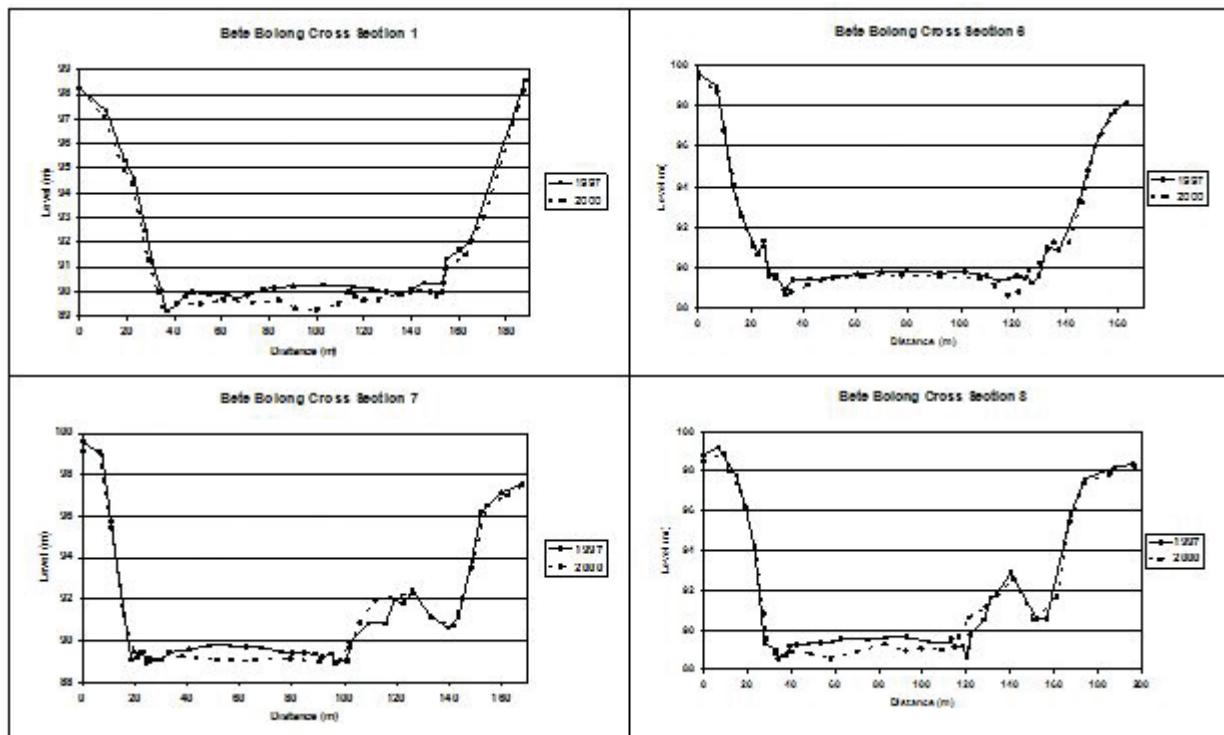
Figure 10: Cross-sections surveyed in 1997 and 2000 at Bete Bolong. See Figure 1 for location of site and Figure 3 for location of cross-sections.

Bed degradation is shown on most cross-sections (Figure 10) and is corroborated by the increases in benchfull mean depth and area (Table 10). Maximum depth did not increase because it only reflects changes in thalweg level which, in this case, have been compensated by erosion across most of the bed (see Figure 10). The thalweg is only a narrow section of the bed between bar avalanche faces and secondary channels (Erskine et al. 1999a). There was also substantial erosion and deposition of in-channel benches, as shown by cross-sections 1, 6, 7 and 8 in Figure 10. These changes support the coarsening of bank sediments documented above. Benchfull channel morphology is a more sensitive indicator of flood impacts than bankfull channel morphology. Floods with a flood
