Rubber ramp and spat rope did not facilitate upstream passage of a galaxiid through a perched culvert

Baker CF *et al.* (2024)
Marine and Freshwater Research **75**,
MF23207.
doi: [10.1071/MF23207](https://doi.org/10.1071/MF23207)

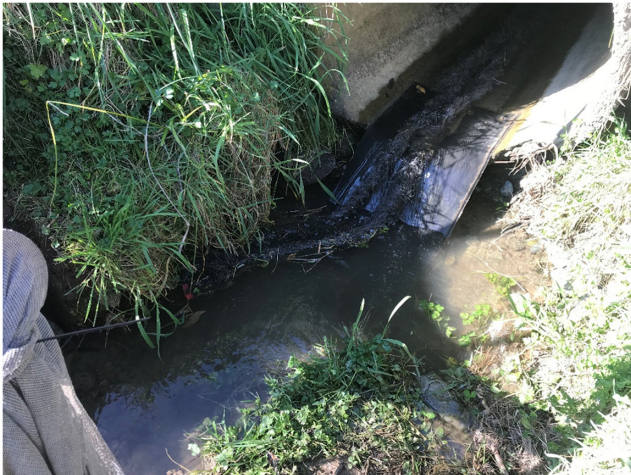
Fig. 1. Rubber ramp and spat rope installed at the outlet of the perched culvert in an unnamed tributary of Oldham Creek, Nelson, New Zealand. Barrier net retaining fish within the test arena is visible to the left of the picture.

A culvert situated on an unnamed tributary stream of Oldham Creek, Nelson, New Zealand (−41.237889°S, 173.325191°E) had previously been remediated by Nelson City Council to facilitate the movement of fish, in particular weak swimming fish such as *G. maculatus*. The culvert is situated ~0.9 km inland from the coast and at an elevation of <20 m above sea level. The 0.9-m-wide, 7.5-m-long perched pipe culvert (drop height at the culvert outlet was ~180 mm) was retrofitted with a 440-mm-wide rubber ramp and two strands of mussel spat rope ('Super Xmas Tree'; Donaghys Industries, New Zealand) that ran along the length of the culvert and over the ramp (Fig. 1). The spat ropes were attached at the upstream end of the culvert inlet but were not attached at the downstream end and floated freely upon reaching the water surface downstream of the culvert outlet (Fig. 1). The rubber ramp was also not attached to the stream substrate so may have changed gradient with different stream discharges, but at the time of testing it was >45°. The flexible rubber ramp had a smooth surface with water depths of between 1 and 2 cm in regions outside of the spat ropes.

After 48 h, all fish were successfully recovered from either the test arena between the culvert outlet and the downstream barrier net (Fig. 1), or within the culvert barrel. No fish had successfully passed the culvert and only four fish (0.79%) had successfully passed the ramp and were located within the culvert at the conclusion of the trial (Fig. 3). Insufficient fish passed the ramp to determine whether there was any statistically significant effect of fish size on success, but the four fish that passed the ramp had a mean length (51.3 mm) and weight (0.39 g) greater than the mean of all fish (Table 1).

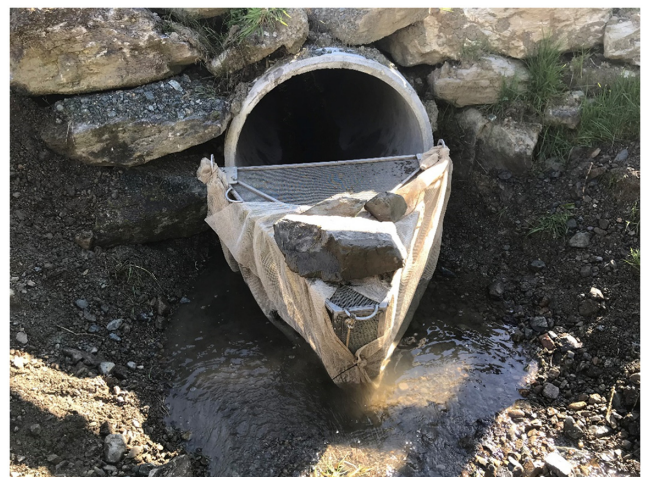
Fig. 2. Whitebait trap installed at the culvert inlet to capture fish successfully passing the structure.

To retain fish at the site and prevent wild fish moving into the test area, two barricades were set 1 m apart at the downstream end of the pool immediately below the perched culvert. These consisted of 2-mm mesh nets weighted at the base and buried into the substrate and attached to metal Y poles that were dug into each stream bank (Fig. 1). To capture fish successfully passing the culvert, an aluminium A-frame whitebait trap was installed at the culvert inlet (Fig. 2). Rocks and 2-mm mesh nets were used to secure the base and edges of the trap at the inlet. The trap was weighted down to prevent movement with any change in flow (Fig. 2).

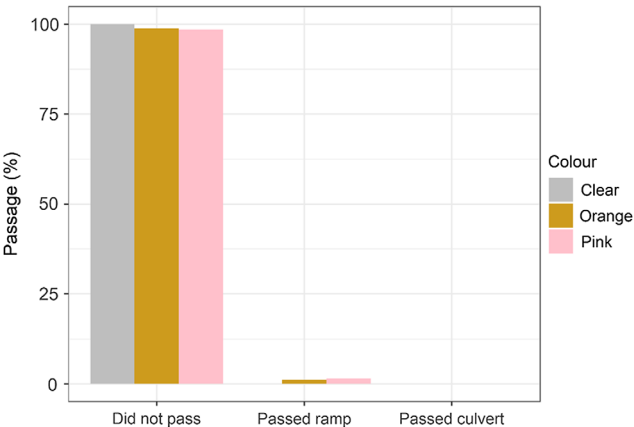
Fig. 3. Percentage of individuals that did not pass, passed the ramp and passed the culvert at the completion of the trial (48 h).

At this site, <1% of marked fish successfully passed the rubber ramp over a 48-h trial period. In comparison, Franklin and Bartels (2012) recorded a mean of 27% passage efficiency for *G. maculatus* over a 9-h trial period at a 15-m-long rock ramp, whereas Doehring et al. (2011) measured passage efficiencies for *G. maculatus* of 21–66% over 3-m artificial ramps (artificial grass substrate) at a range of gradients (4-h trial period). Likewise, Baker (2014), Baker and Boubée (2006) and Franklin et al. (2021) all recorded 3-h passage efficiencies for *G. maculatus* ranging from 20 to >90% over experimental fish ramps up to 3 m long with gradients of 15–30°.
