# LPG stored at the wildland–urban interface: recent events and the effects of jet fires and BLEVE

**Background.** Jet fires and boiling liquid expanding vapour explosions (BLEVEs) are potential events when a vessel containing liquefied petroleum gas (LPG) is exposed to fire. Events involving domestic LPG tanks have occurred at wildland–urban interface areas in Portugal, the USA, Spain and Greece. **Aims.** Evaluation of the pressure relief device (PRD), the type of cylinder and the effects of jet fires and BLEVEs. **Methods.** LPG cylinders manufactured with steel and composite materials were exposed to fire. Hydrostatic tests were carried out to compare the burst pressure without fire influence. Fourteen accidents that occurred during wildfires are described. **Key results.** The presence of a PRD and the right choice of type of cylinder as well as cylinder location may avert major accidents. The jet fires and fireball radiation are also described, as well as the maximum distance reached by cylinder fragments. **Conclusions.** The tests showed that the burst pressure in the test of a cylinder without PRD under fire was significantly lower when compared with the hydrostatic tests

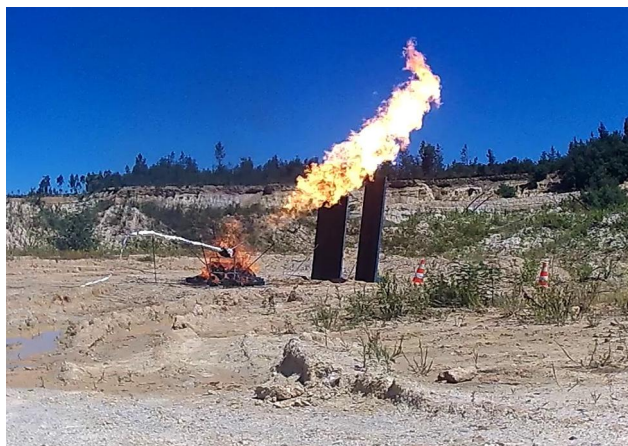
**Fig. 3.** Image of test TICB showing the jet fire.

values between 700 and 1200 K. The jet fire happened three times, lasting 55, 20 and 25 s.

A jet fire with a similar length and width to the jet fire noted in test T1CB was observed during test T2SP. The infrared camera was set to record between 273 and 824 K in order to record the flame size, but the flame temperature in the centre of the jet fire was higher than 824 K. Other authors (Lowesmith *et al.* 2007; Palacios *et al.* 2012) found

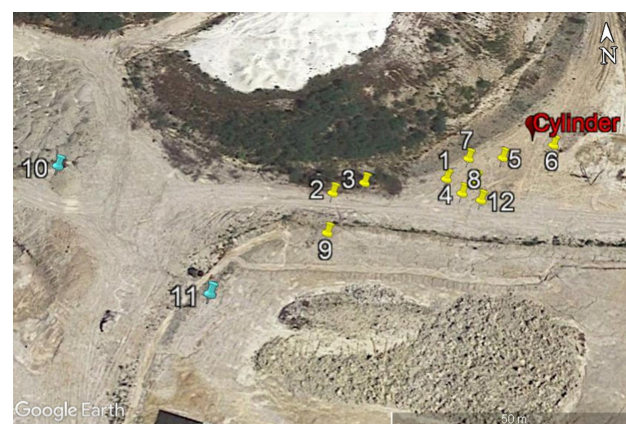
**Fig. 6.** Fragments on the field after test T3SP: primary fragments (blue) and secondary (yellow).

As an effect of the BLEVE, cylinder fragments (primary fragments) were projected; other fragments (secondary fragments) – for instance pieces of the support, fixing rods and instruments – were also projected. The cylinder rupture generated two major pieces, the first of 10.63 kg weight and another 4.33 kg. Thus, 97.72% of the cylinder weight was recovered after the burst. There were several pieces of secondary fragments scattered randomly in the field.

The maximum distance reached by a fragment was 113 m, and the maximum velocity reached was  $252 \text{ km m}^{-1}$ . The fragments that reached the largest distances were the primary fragments (Fig. 6, Table 4). Table 4 also shows the fragment distribution, with the respective weight and distances from the initial point. The smaller primary fragment (fragment ref. 174) reached a higher distance when compared with the heavier primary fragment (fragment ref. 175).
